# MIPS R4000PC/SC Errata, Processor Revision 2.2 and 3.0

May 10, 1994

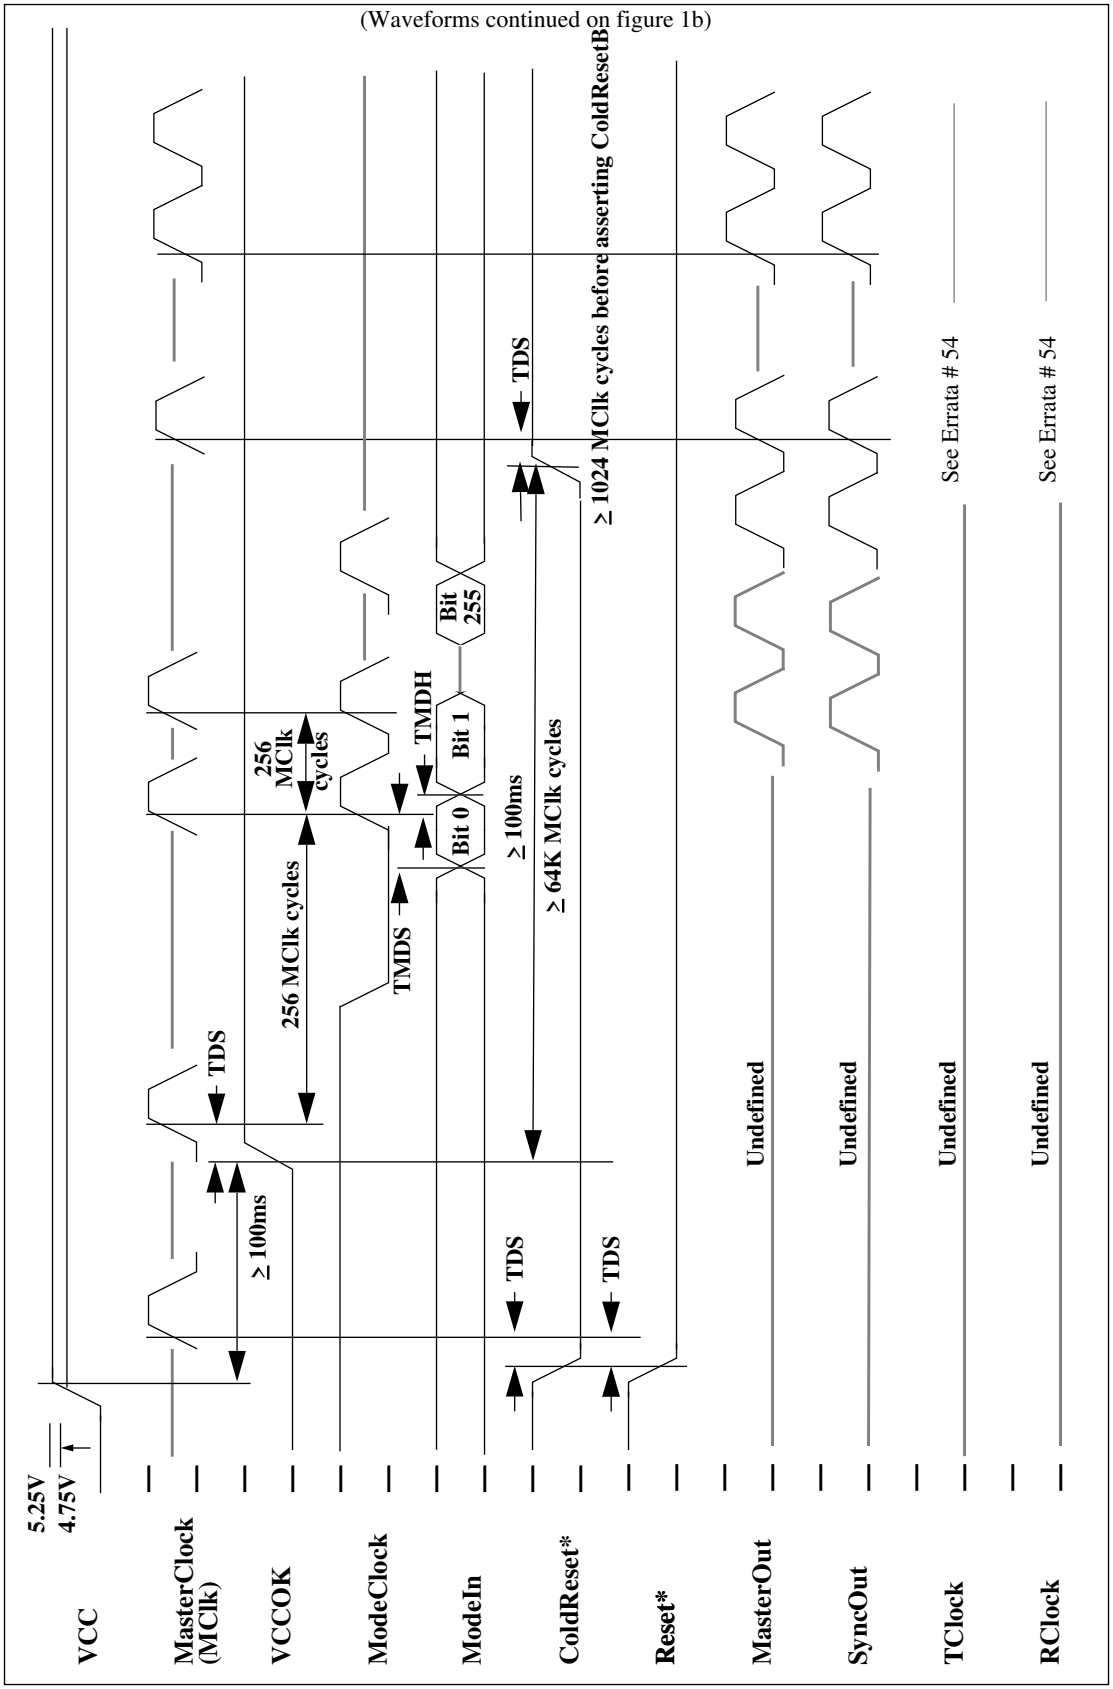
Figure 1a: Power-on Reset or Cold Reset - Workaround for Bug# 54

**54.** R4000PC, R4000SC: During the power up sequence, the period of TClk and RClk may not be as expected for at least 1024 MasterClock cycles following the de-assertion of ColdResetB. The above bug is true for all system interface divisors. Furthermore, if the system interface divisor other than 2 (i.e. 3,4,6 & 8) is used, TClk and RClk's rising edge may not align to the rising edge of the MasterClock, as specified.

This may not be a problem for systems using only TClk for the external logic. However, certain systems like -

this bug may cause problems.

Thus, for system with interface divisor set to two, the only violation will be that the TClk and RClk's period might not be valid within 64 MasterClock after the ColdResetB is de-asserted.
